CHARACTERIZATION OF MECHANICAL DAMAGE MECHANISMS IN CERAMIC COMPOSITE MATERIALS

TECHNICAL REPORT

ONR CONTRACT NO. N00014-84-C-0213
ONR Contract Authority NR 032-553/11-10-83(430)
SwRI-8124

By
Southwest Research Institute
San Antonio, Texas

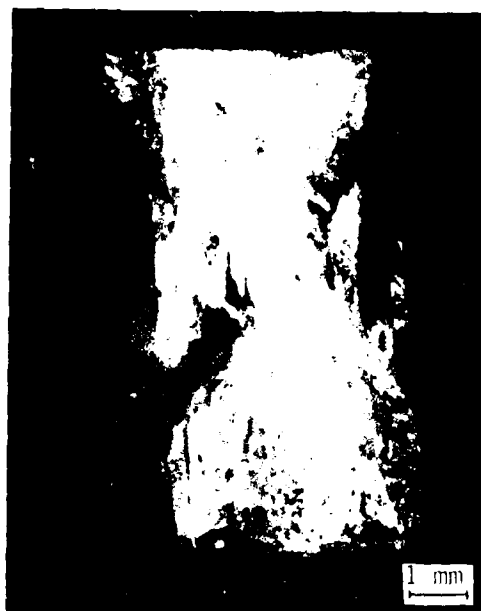
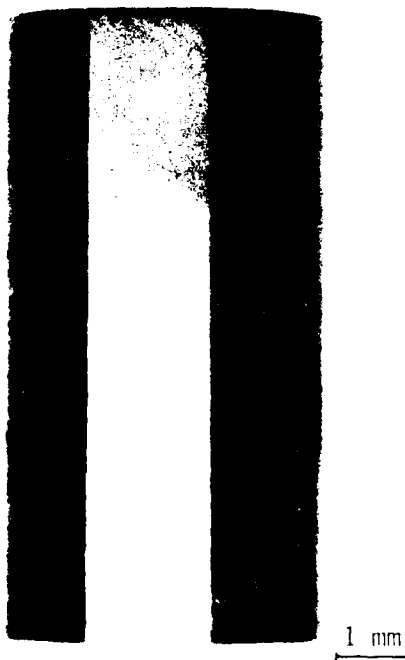
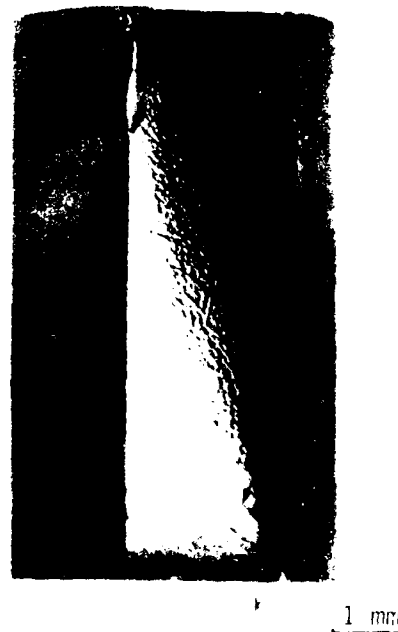
(a) Shear fracture, 5Y-PSZ, 700C.

(b) Fracture by coalescence of multiple shear microcracks, 20Y-PSZ, 700C.

(c) Planar slip bands, 5Y-PSZ, 700C, $\epsilon_p = 1.5\%$.

(d) Apparent wavy slip bands (arrow), 20Y-CSZ, 700C, $\epsilon_p = 1.5\%$.

Figure 7. Macroscopic views of fracture and deformation in 5Y-PSZ and 20Y-PSZ.

Specimens compressed to failure, i.e., a state of negligible load-bearing capacity, are shown in Fig. 7(a) and 7(b). The 5Y-PSZ crystal fails by sliding on several distinct, macroscopic shear planes, while the 20Y-CSZ specimen has failed due to the coalescence of multiple shear microcracks, following extensive plastic flow within the shear bands. It should be noted that the latter specimen is still intact. Part of the path each

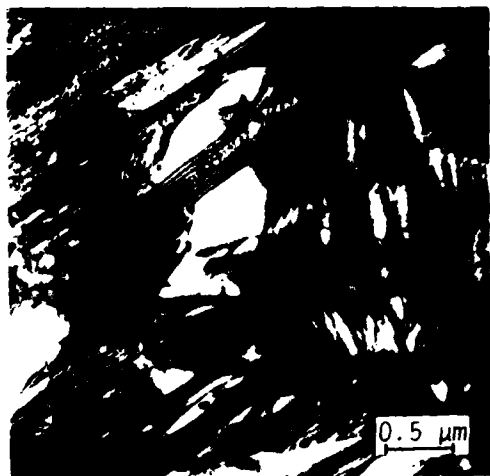
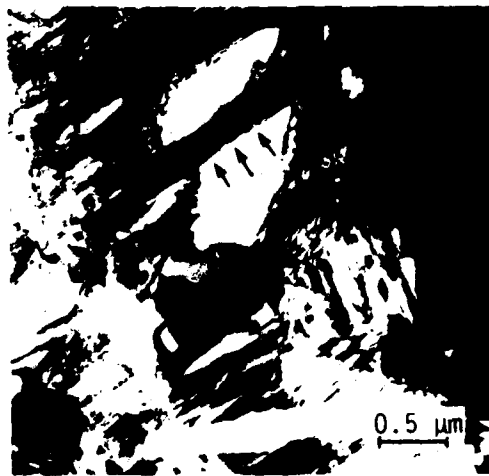
(a) $T = 283^\circ\text{C}$, $\epsilon_p \approx 0.5\%$; tweed microstructure, arrows indicate dislocations.

(b) $T = 700^\circ\text{C}$, $\epsilon_p \approx 1.5\%$; distorted and faulted microstructure.

(c) Altered contrast, same region as in (b), showing possible extended dislocations (arrows) in fault.

Figure 13. Transmission electron microscopy of deformed 5Y-PSZ. Foils are normal to stress axis.
